PILKINGTON
NSG Group Flat Glass Business

Technical Information

ATS-137-4
2011/01/27

NEW IMPROVEMENTS IN THE APPEARANCE OF INSTALLED Pilkington Energy Advantage™ Low-E Glass

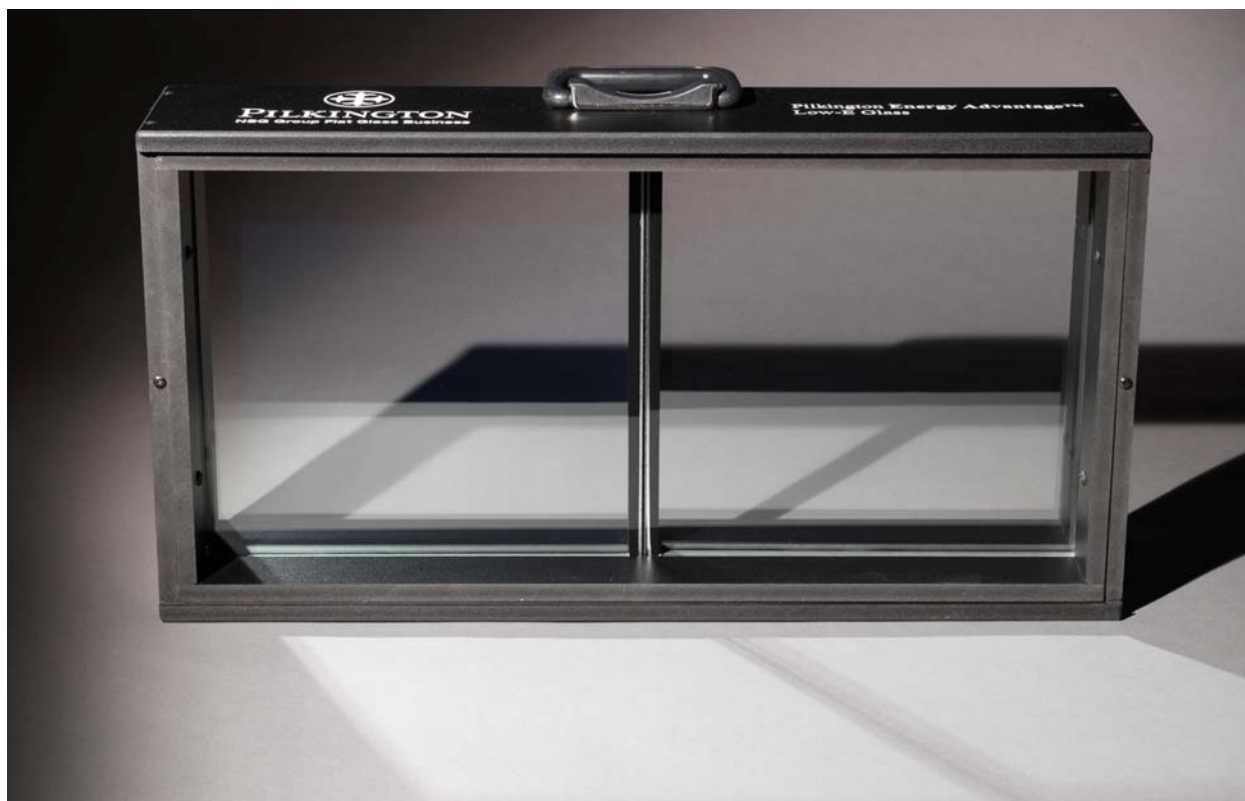
Pilkington **Energy Advantage™** is made of an extremely fine polycrystalline hard material that under most lighting and viewing conditions cannot be seen:

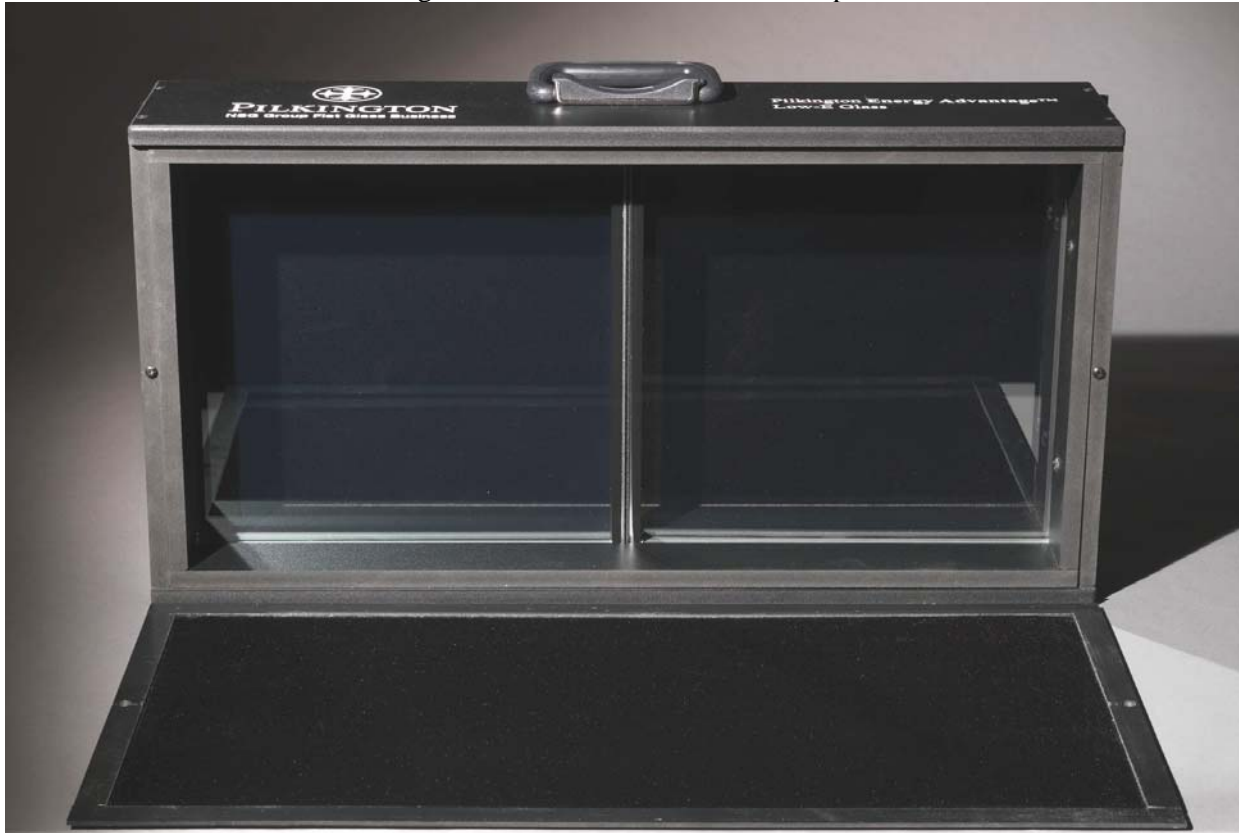
It is possible to discern the presence of the coating under certain lighting conditions, such as when bright sunlight shines directly onto partly shaded, coated glass and there is deep shade on both sides of the glass. Using the extreme lighting conditions of a studio spotlight to simulate direct sunlight (with the same set-up as in the photo above), and eliminating (with black velvet) the distracting transmitted and reflected images of a typical window, the residual haze of the older (2010 and earlier) product can be seen in the left hand IG unit of the following photo. The IG unit on the right hand side of the original photo below barely shows the miniscule amount of haze that can be found in 2011 production of 2.5, 3.0 and 4.0 mm thick Pilkington **Energy Advantage™**.

2010 and earlier glass

2011 production

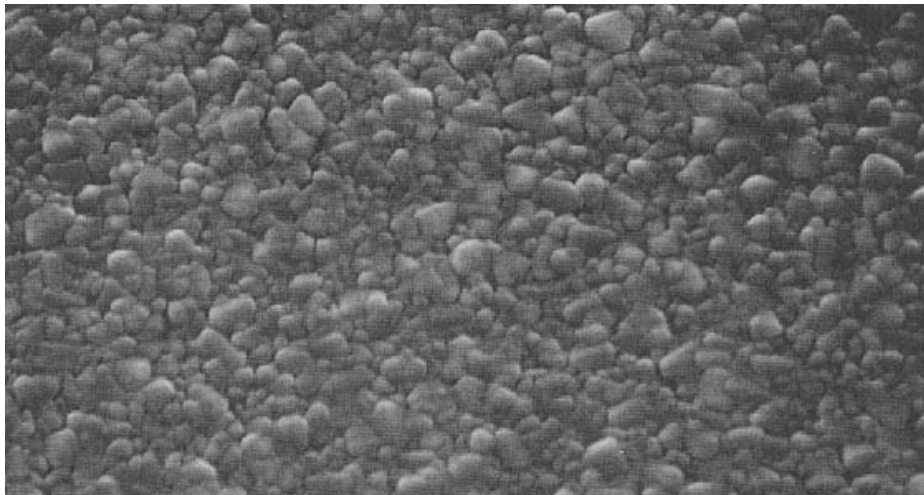
Fig.1. Typical grain structure, magnified 20,000 times.

Pilkington **Energy Advantage**[™] pyrolytic coatings are made by the chemical vapor deposition (CVD) process, creating a hard polycrystalline layer of tin oxide over color suppression underlayers. In an electron microscope picture, the polycrystalline structure of the surface of the tin oxide top coat can be seen as a layer of closely packed grains. Daylight can easily pass, with less than 1% scattering, through this coating because each grain is actually smaller than the wavelength of visible light. The illustration below shows the surface of the coating magnified 20,000 times.

The extremely small size of the grains makes them invisible in most lighting conditions.

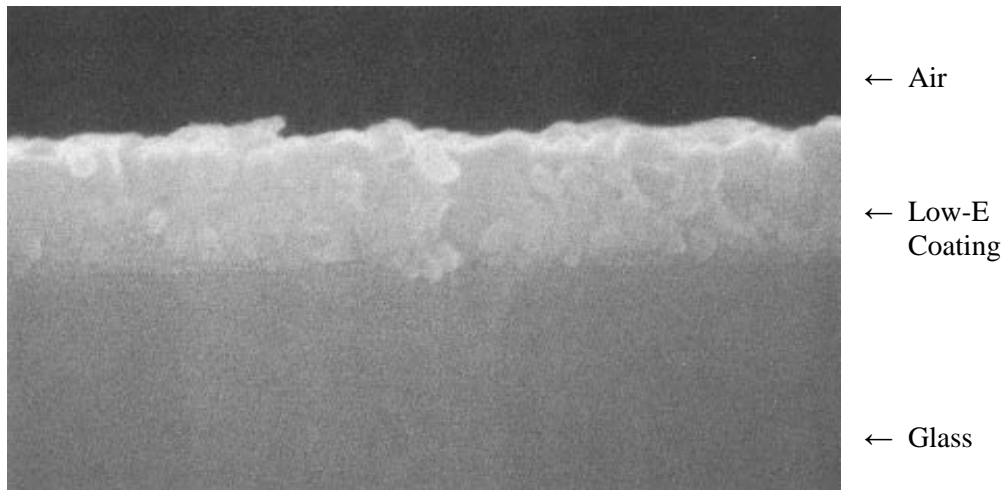
Fig.2. Cross-section showing coating uniformity, magnified 50,000 times.

The following electron microscope image shows a cross-section through the Pilkington **Energy Advantage**[™] Low-E glass coating. The polycrystalline nature of the coating contrasts with the non-crystalline 'super-cooled liquid' nature of the solid glass underneath the coating.

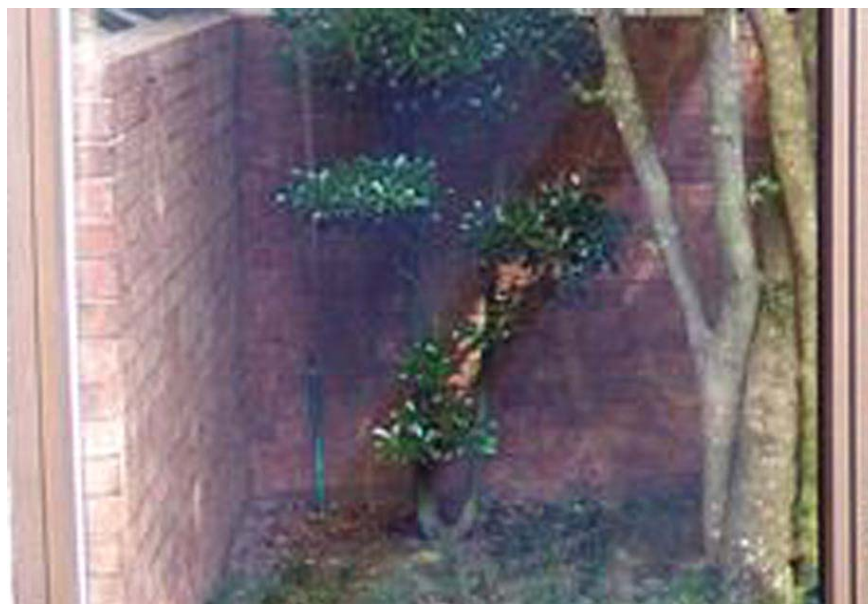
It is possible to discern the presence of the coating under certain lighting conditions, such as when bright sunlight shines directly onto partly shaded, Low-E coated glass and there is deep shade on both sides of the glass. When looking out through the glass towards a deeply shaded background, the short wavelength component (blue) of the sunlight appears slightly scattered. This gives the coating a uniform, very faint blue appearance visible in the sunlit area. Longer wavelength red light is less scattered. In the 2003 photo below the haze was made more noticeable by the complete lack of any visible haze in any contrasting glass shaded areas, such as in the diagonal shadow on the glass.

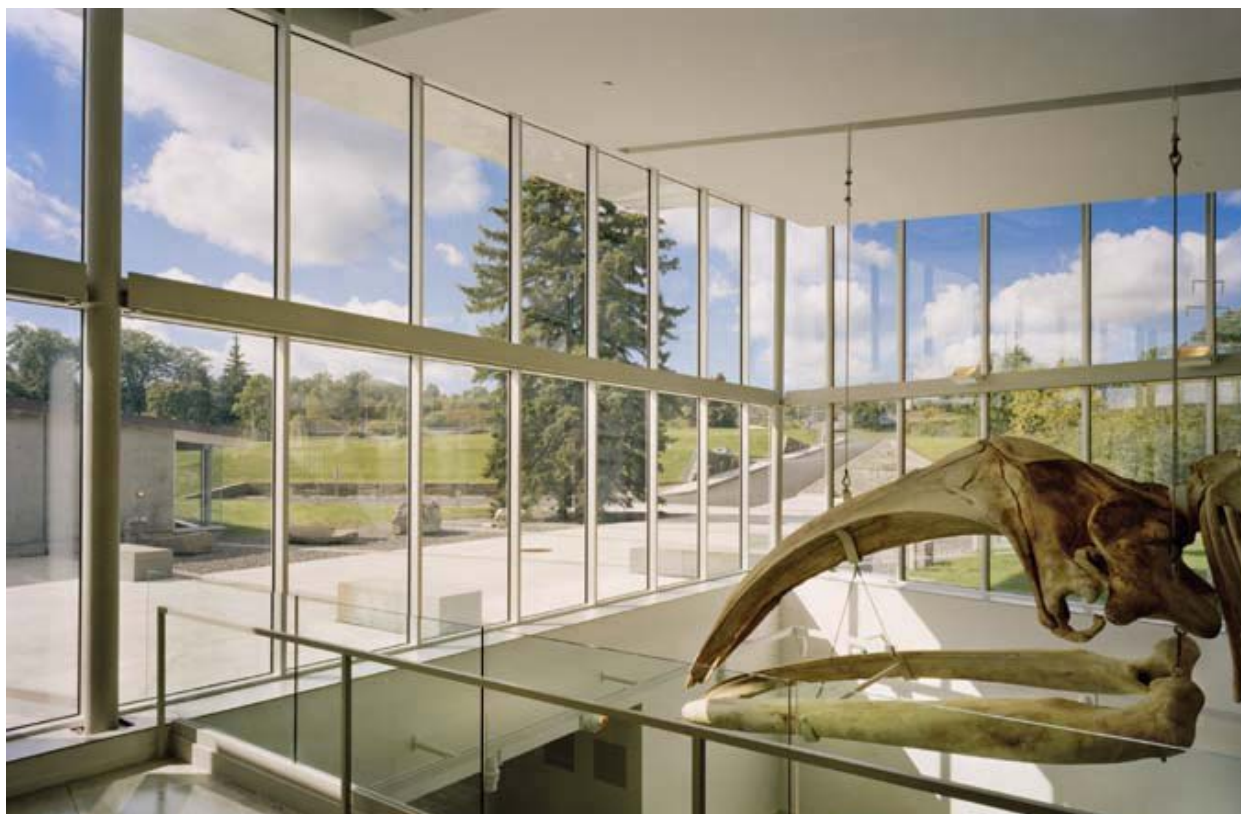
Haze is only visible when direct sunlight shines on the glass. With typical lighting on most Low-E coated windows, and for the greater part of the day, there is no haze visible. The following photo is an example with no visible haze, even in the sunlit Pilkington **Energy Advantage**[™] Low-E glass (pre 2011 production), because there is no deep shade beyond the glass.

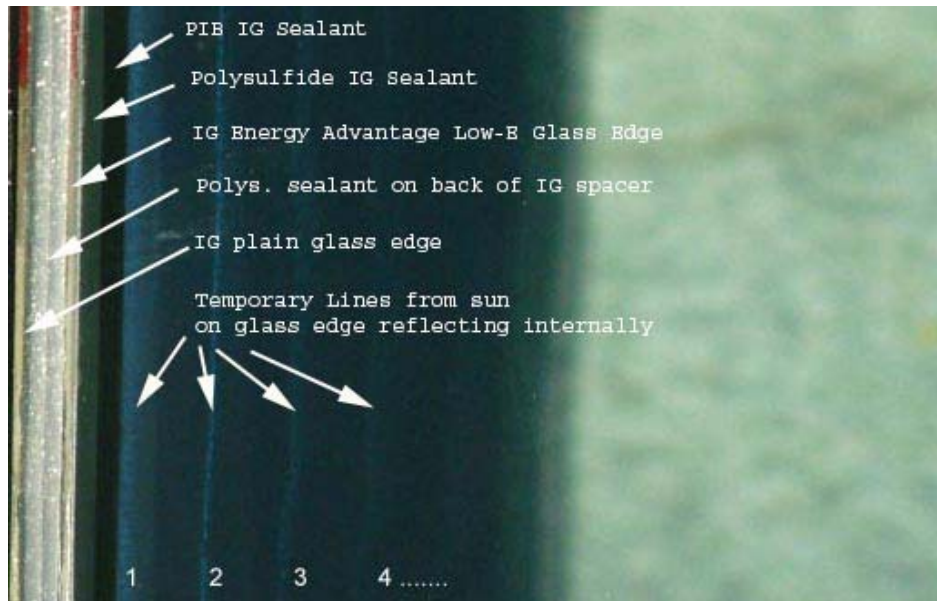
Fig.3. Temporary or Transient Lines caused by sunlight on an exposed glass edge

Before a light of Low-E coated glass is glazed into a frame, sunlight, or a bright light, shining directly onto the glass cut edge can internally reflect within the body of the glass and produce a series of faint parallel lines a few inches from the glass edge where some reflected light is scattered by the coating. The photo below shows these lines. They are more visible on the left hand side of the glass where there is a dark background behind the glass.

This effect completely disappears when the glass edges are shaded by being glazed into a normal sash or frame.

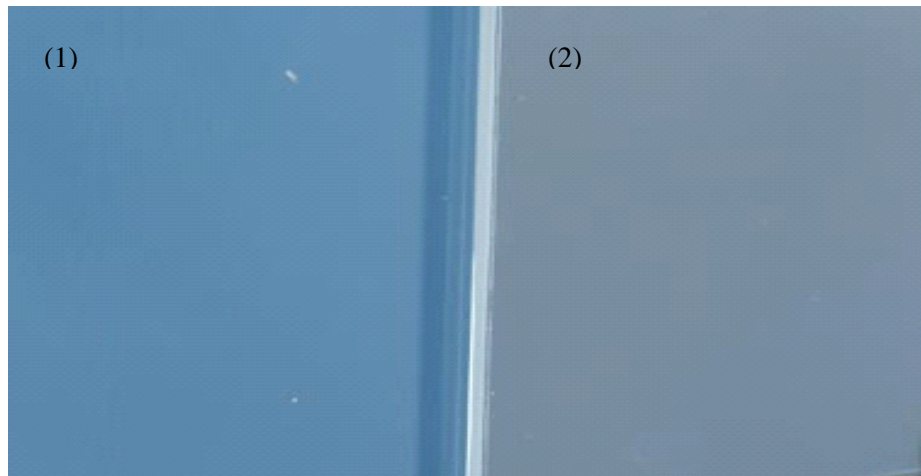
An alternate way to achieve the very high thermal insulation provided by the pyrolytic 'hard' Low-E coating in a double glazed unit, is to use a 'soft' sputtered coating produced off-line in a vacuum chamber. Such coatings must be protected from humidity by being sealed into an IG unit. The sputtered coating is typically removed or ground off at the perimeter to allow effective insulating glass sealant adhesion. Sputter coatings usually have some reflected color as seen in the left hand glass (1).

Sputter coat IG reflected color of a grey sky (1). The same sky reflected in adjacent clear glass IG (2).

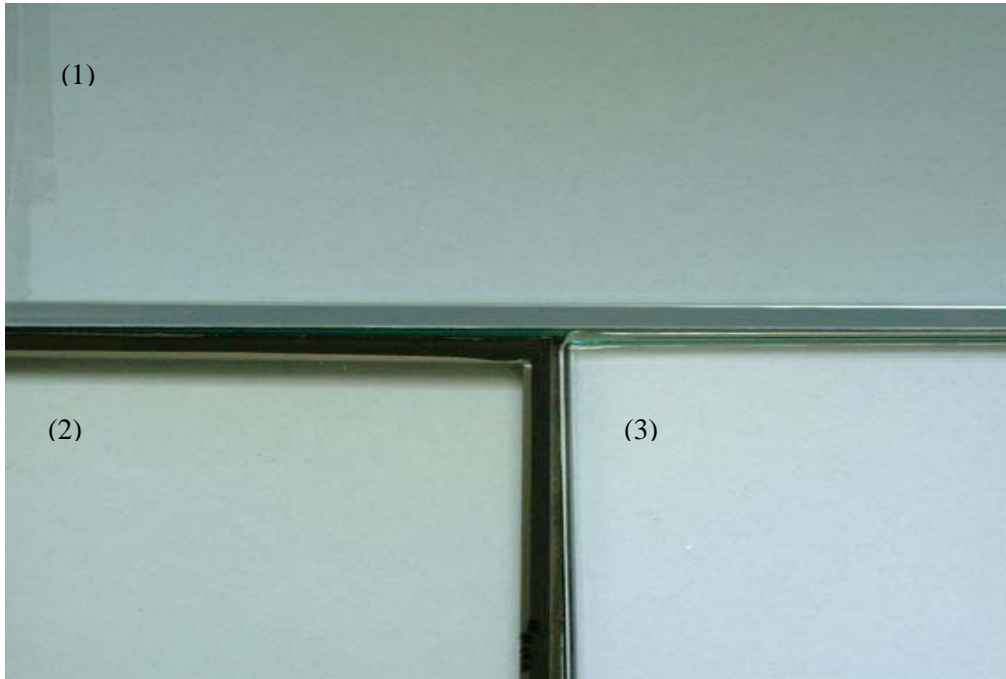
Viewed in transmission, in the photo below, the top IG unit (1) is sputter coated Low-E, the lower left unit (2) is Pilkington **Energy Advantage™**, and the lower right IG unit (3) is clear glass with no Low-E.

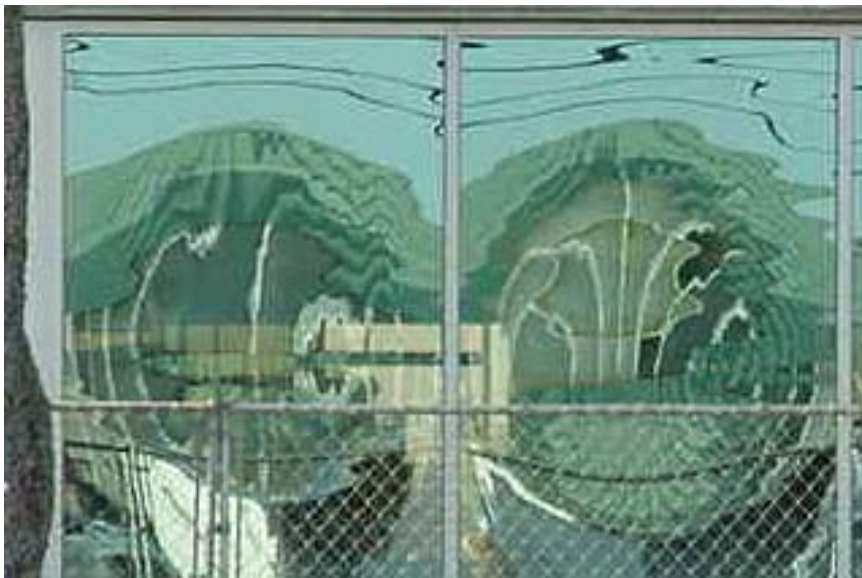
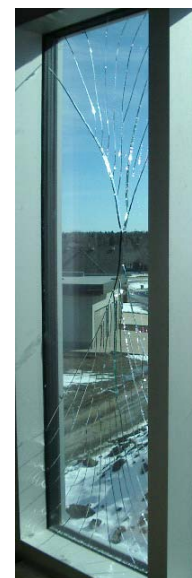
The use of three lites of plain glass in a triple glazed unit can also give insulation values similar to a double glazed unit with a Low-E coating. But this involves a thicker and heavier window unit, with increased reflectivity, and more distortion in the reflected images when weather changes cause greater expansion and contraction of the wider total air space. There is an increased risk of breakage with improperly balanced air spaces, compared to sealed double glazing.
